## Early loading implant failure of congenitally missing maxillary lateral incisor after orthodontic space opening: A case report

**Key words:** Implant failure; lateral incisors missing; orthodontic space opening; osseointegration.

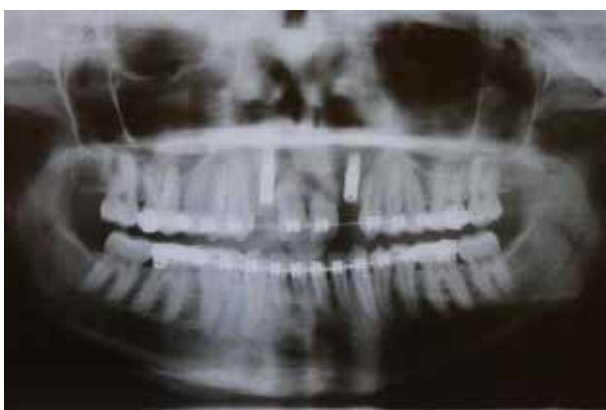
She had received endosseus implants (XiVE® S plus Screw Implant, D 3.0/L 13) each side and after five months second stage surgery was done (Fig 1).

Figure 1. Post implant insertion panoramic view.

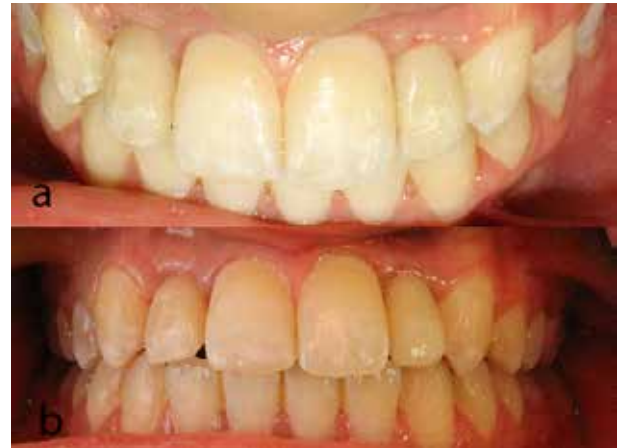
Figure 3. Delivered restorations after 1 months

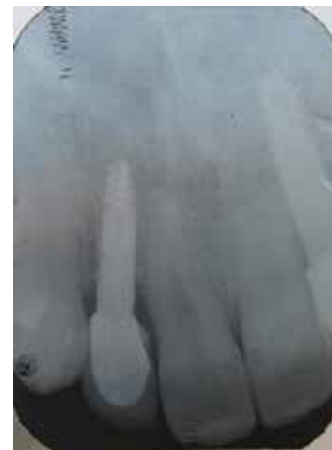
Figure 4. Radiographic periapical view of right lateral implant (remained excess cement).

In some recent reports, excess cement residue is considered as a reason of implant failure, because the gingival fiber tissue around the implant does not provide enough protection [10]. However, it is not proved yet that the presence of excess cement surrounding an implant may be a triggering factor for failure, in a study of Burbano et al. Peri-implant disease was associated with five commercially available dental cements [11]. In this patient, a small cement residue was remained so it could be lead to start an inflammation and destroy the integration.

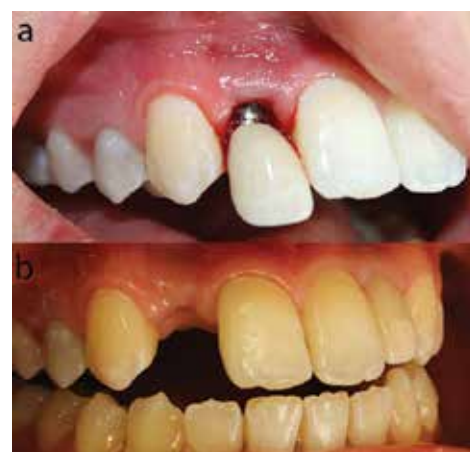
After four months, the patient returned with complaining of mobility of right lateral implant restoration. On examination, the crown was not uncemented. The gingiva was pink, with normal texture and there was no pain, exudate and swelling. The mobility was in horizontal direction, neither vertical nor rotational direction. The radiographic evaluation showed normal levels of bone with no pathology, but a little cement was remained in mesial margin of the crown (Fig 4). The most probable cause was seemed to be abutment screw loosening. Therefore, we decided to remove the crown and retighten the abutment screw. While trying to remove the crown, suddenly crown and fixture removed together with little bleeding. Unfortunately, the implant was failed and explantation was done (Fig 5).

Figure 5. a) Crown and fixture removing together. b) After 4 days of explantation.

In this report a narrow implant was inserted in the anterior region of maxilla, where the space gained by orthodontic treatment. Implant failure occurred in the first months of loading and the single sign was little mobility without radiographic evidence. Mobility is the key sign of implant failure, which could be vertical, horizontal or rotational. Rotational mobility is due to an immature bone/implant interface, but horizontal and vertical mobility may reflect bone loss and the presence of soft tissue capsule. Mobility could be without radiographic changes [3]. In this case, horizontal mobility was indicated the osseointegration failure and fibrous encapsulation.

As the failure happened in the first months of loading, its probable reason is related to biomechanical factors of the implant-bone interface; amount of force applied to the prosthesis and the density and quantity of the bone around implant [2]. In this case, the amount of force had been controlled through exact occlusal adjustment with light contact in centric relation and no contact in excursion movement. So quality and quantity of adjacent bone should be reassessed.
