## A Combination of Internal and External Connection Screw-Retained Implant Restorations in Esthetic Zone Rehabilitation: A Case Report

Article Type:  
Case Report

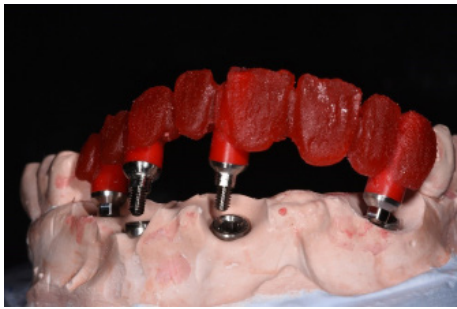
Figure 3. Resin pattern while the anterior abutment connection is made non-hex by handpiece.

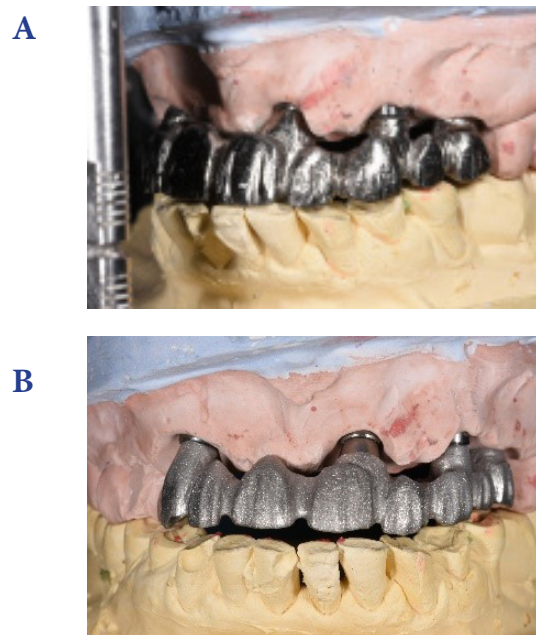
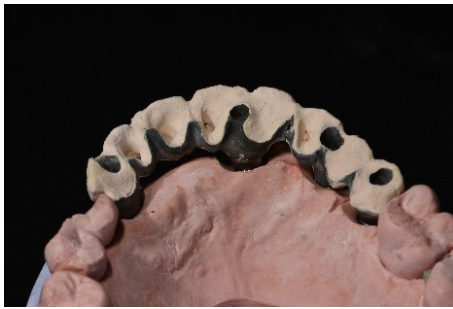
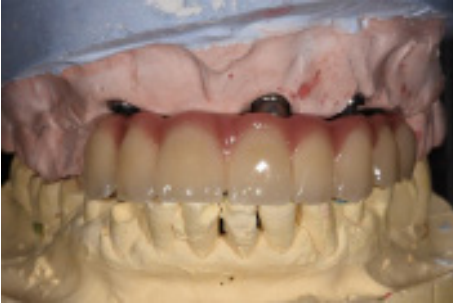
*Figure 7.* The final frame (A) after preparation (B) after two OPEC firing stages (pay attention to the OPEC termination point) (C) Final restoration after the glaze and polishing stage (D).

Then the necessary buildups and supports for this frame were created by wax. (Figure. 6 a to c). Finally, the frame after casting with base metal alloy (Supercast Industries base metal alloysuper cast) and the necessary adjustments for the frame was sent for the frame test, and after receiving the Prosthodontist's confirmation that the frame is passivefit and it was suitable, the restoration entered the porcelain stage Using fuse-to-metal porcelains (VITA Zahnfabrik VMK Master kit). At first, after the Preparation of the frame for this step [4]. the surface of the frame was baked twice using Opaque wash and Opaque, and the final teeth were shaped on the surface with dentine buildup and enam-

el. (Figure 7 a to d).

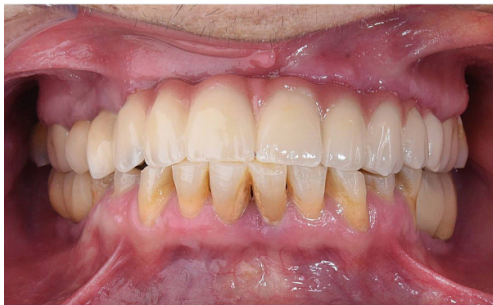
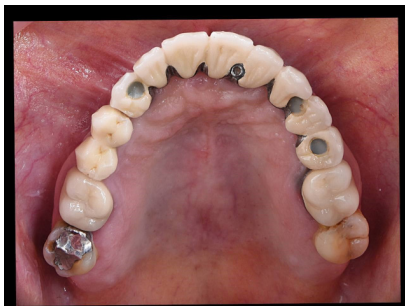
*Figure 8.* Restoration delivered to the patient, buccal view (a), occlusal view (b).

Finally, the restoration was delivered to the patient and according to the pictures of the final prosthesis, it benefited from the function and quality of the prosthesis. Also, in the next follow-ups after 5 8 months, the patient is using the prosthesis without any problems, and things like screw loosening, chipping, and so on. Were not observed. (Figure 8 a,b and c).
