## A Combination of Internal and External Connection Screw-Retained Implant Restorations in Esthetic Zone Rehabilitation: A Case Report

Article Type:  
Case Report

This case report describes the rehabilitation of the Esthetic-Zone of the maxillary jaw of a 70-year-old female patient by using 4 implants (BEGO Semados® RS/R SX) with the challenging position of her implants due to her age and channel access of the Fixtures and also the Difficulty in supplying desired prosthetic parts due to existing problems. In the beginning, the treatment plan was to reconstruct the mouth using conventional restoration with UCLA abutments, but due to the unavailability of non-hex abutments As well as the failure to achieve the desired Esthetic demands of the patient by using this treatment plan, especially in the anterior implant area of the jaw, it Innovatively was decided to use a combination of cylindrical abutments (BEGO MultiPlus system) and UCLA abutments to Design and fabrication of the Final restoration.

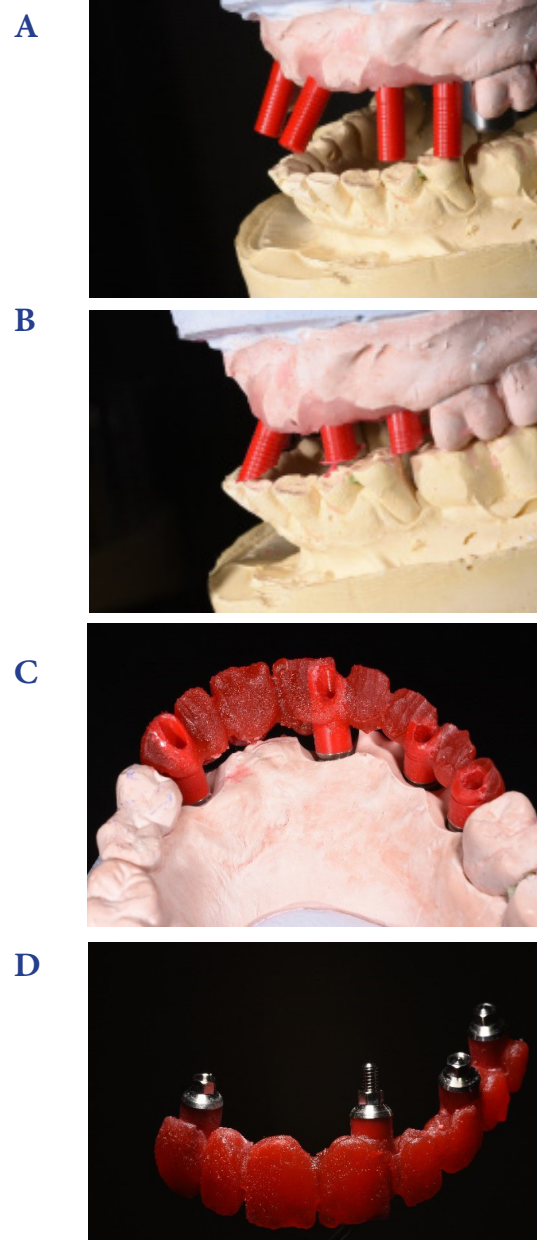
*Figure 2.* UCLA abutments closed on the cast (a). After cutting the abutments (b). Resin pattern from lingual view (C), buccal view (D).

to the financial conditions of the patient and Biomechanics and limitations of zirconia restorations [2]. Also, due to the strong desire of the patient to maintain. Appropriate lip support and maintain the beauty of the restoration, it should have an overjet as much as possible and be made edge-to-edge with the lower jaw teeth. After the examinations with the Prosthodontist and also consultation with the companies that supply prosthetic parts of the relevant brand in the country, 4 UCLA metal connection abutments with hex (Bego Universal Abutment PS UNI\* hex) due to the lack of non-hex UCLA (which is the best choice in this cases [3]). And also an emphasis on the use of original Prosthetic parts for restoration was prepared. After cutting the abutments based on the occlusal plan, a Pattern resin (GC Initial® PATTERN RESIN™ LS) shell was made on them using the GC resin pattern as a Verification jig and also to determine the approximate position of the teeth in the mouth, and then it was sent to the Prosthodontist doctor for checking and final examination Before making the restoration frame). (Figure 2 c and d).

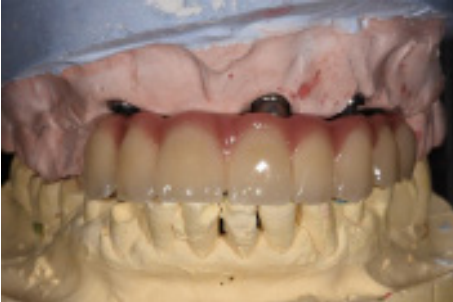
Figure 7. The final frame (A) after preparation (B) after two OPEC firing stages (pay attention to the OPEC termination point) (C) Final restoration after the glaze and polishing stage (D).

Then the necessary buildups and supports for this frame were created by wax. (Figure. 6 a to c). Finally, the frame after casting with base metal alloy (Supercast Industries base metal alloysuper cast) and the necessary adjustments for the frame was sent for the frame test, and after receiving the Prosthodontist's confirmation that the frame is passivefit and it was suitable, the restoration entered the porcelain stage Using fuse-to-metal porcelains (VITA Zahnfabrik VMK Master kit). At first, after the Preparation of the frame for this step [4]. the surface of the frame was baked twice using Opaque wash and Opaque, and the final teeth were shaped on the surface with dentine buildup and enam-

el. (Figure 7 a to d).

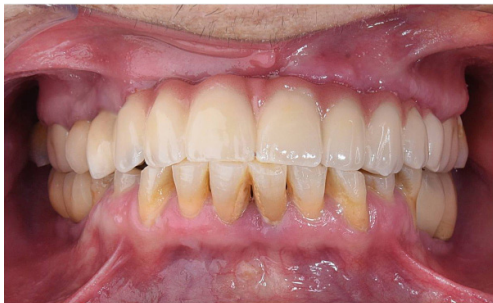
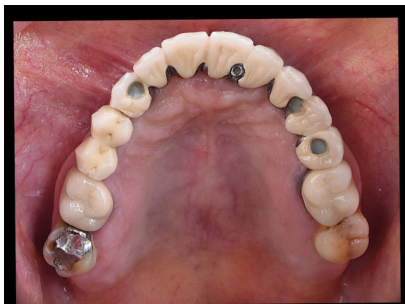
Figure 8. Restoration delivered to the patient, buccal view (a), occlusal view (b).

Finally, the restoration was delivered to the patient and according to the pictures of the final prosthesis, it benefited from the function and quality of the prosthesis. Also, in the next follow-ups after 5 8 months, the patient is using the prosthesis without any problems, and things like screw loosening, chipping, and so on. Were not observed. (Figure 8 a,b and c).
