A Combination of Internal and External Connection Screw-Retained Implant Restorations in Esthetic Zone Rehabilitation: A Case Report

Article Type:
Case Report

This case report describes the rehabilitation of the Esthetic-Zone of the maxillary jaw of a 70-year-old female patient by using 4 implants (BEGO Semados® RS/R SX) with the challenging position of her implants due to her age and channel access of the Fixtures and also the Difficulty in supplying desired prosthetic parts due to existing problems. In the beginning, the treatment plan was to reconstruct the mouth using conventional restoration with UCLA abutments, but due to the unavailability of non-hex abutments As well as the failure to achieve the desired Esthetic demands of the patient by using this treatment plan, especially in the anterior implant area of the jaw, it Innovatively was decided to use a combination of cylindrical abutments (BEGO MultiPlus system) and UCLA abutments to Design and fabrication of the Final restoration.

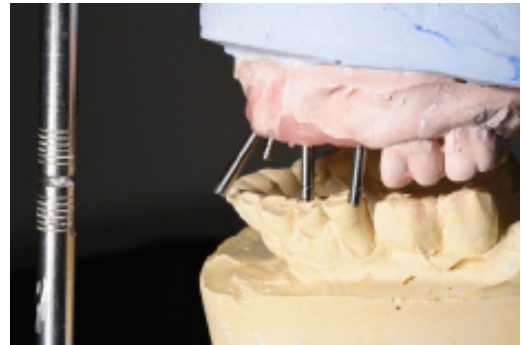
Figure 1. The condition of the casts after mounting (note that the impression screws of open technique couplings are used as a guide to determine the path of the implants).

A 70-year-old female patient with four Bego bone level implant units (BEGO Semados® RS/RSX) in positions (13,21,23, and 25) that were 6 months after surgery and implant placement were referred to the Prosthodontist to take the final impression for the prosthetic phase by means of A silicone impression material) Zhermack Hydrorise® A-Silicone). Then the impression was sent to the laboratory for making the restoration. Due to the old age of the patient, as well as the location of the implants and their access holes and the severe wear marks On the teeth of the lower, along with severe protrusive tilt of the lower jaw teeth, which gave the patient's mouth a state similar to class 3 patients which had a similar appearance to Kennedy class 3 patients (Figure 1), it was decided that The restoration should be made of screw-retained and PFM type according

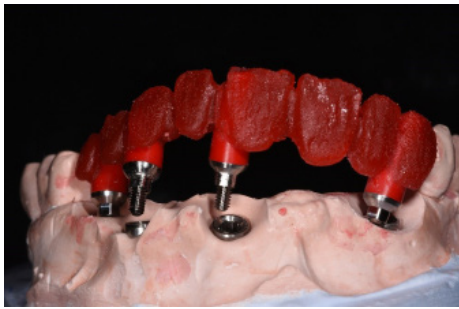
Figure 3. Resin pattern while the anterior abutment connection is made non-hex by handpiece.

After examining the resin pattern, the problem of the frame not sitting was known due to the different angles of the connection of the implants with each other, so the anterior. Fixtures access channel had a severe buccal tilt, which led to the problem of parallelizing it with other connections And as a result, it led to the inability to design an identical insertion path for all abutments. In the first face of this problem, The hexagonal part of the anterior abutment attachment was removed (manual non-hexing of the abutment by using tungsten carbide and diamond burs) and after that, the resin pattern was tested again inside the mouth. The result was the siting of the frame with great difficulty, as well as the presence of rock and Not having passive fit inside the mouth. (Figure 3). In the second encounter, it was decided to make a prosthesis with two pieces: in such a way that implants 13 and 21 are splinted with each other (and support teeth 13 to 21) and implants 23 and 25 are also splinted with each other (and teeth support 22 to 25).

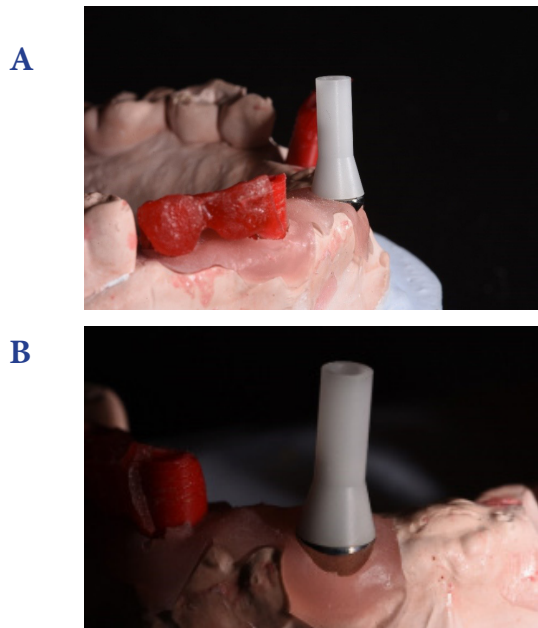
Figure 4. The piece prepared by the company Proximal (A) Buccal view (B).

part (burn-out plastic) (BEGO MultiPlus system). In this treatment plan by placing a multi-unit abutment. Instead of the UCLA abutment, which was in the place of the anterior fixture in the previous treatment plan, the angle of the anterior implant connection was modified and paralleled with other connections. And finally, using the cylindrical part as a part of the frame design pattern was completed. After examining this solution and consulting with the Prosthodontist and companies supplying parts, unfortunately, a similar piece but with a larger gingival height was the only available piece, so that piece was inevitably prepared and placed on the stone cast for examination. (Figure 4).

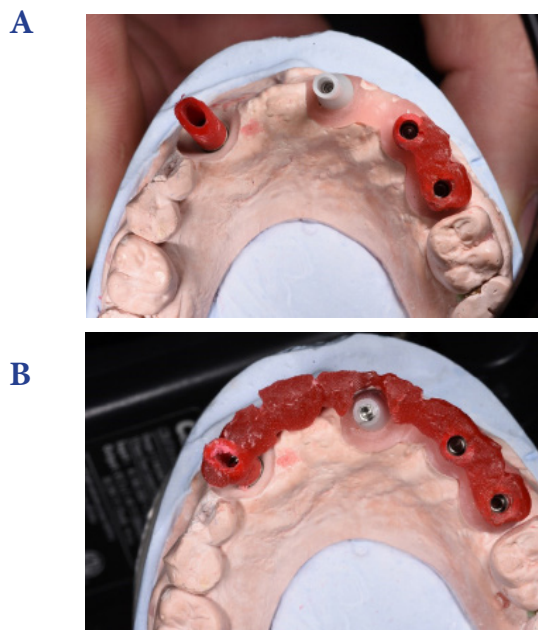
Figure 5. Placing the multi-unit abutment (a) Restoring the resin pattern around the new abutment (b).

After placing the multi-unit abutment with its cylindrical piece, the anterior of UCLA abutment, removed from the Resin pattern in a way the arrangement of the teeth in the Resin pattern remained (because the arrangement and placement of the teeth were approved by both the Prosthodontist and the patient) and then the Resin pattern repaired with the remaining abutments on the cast. Here, i.e. the show of the metal part of the multi-unit abutment inside the mouth, because the gingival height and diameter of the multi-unit abutment were much larger than the UCLA abutment, and Considering its placement in the mouth, this case had a negative effect on the beauty of the patient. (Figure. 5 a and b). After the examination, dental technician was forced to prepare and grind the multi-unit abutment to reach the appropriate diameter and dimensions in order to cover the part that is visible in the mouth with a frame and pink porcelain (VITA Zahnfabrik VMK Master Gingiva powder). After that, the connection area of the cylindrical part was cut as far as possible (up to the connection part with the multi-unit abutment) and designed again with wax (DeguDent PLAS-TODENT® ART LINE) based on the prepared part of the multi-unit abutment, and finally, the Resin pattern using that reconstruction.

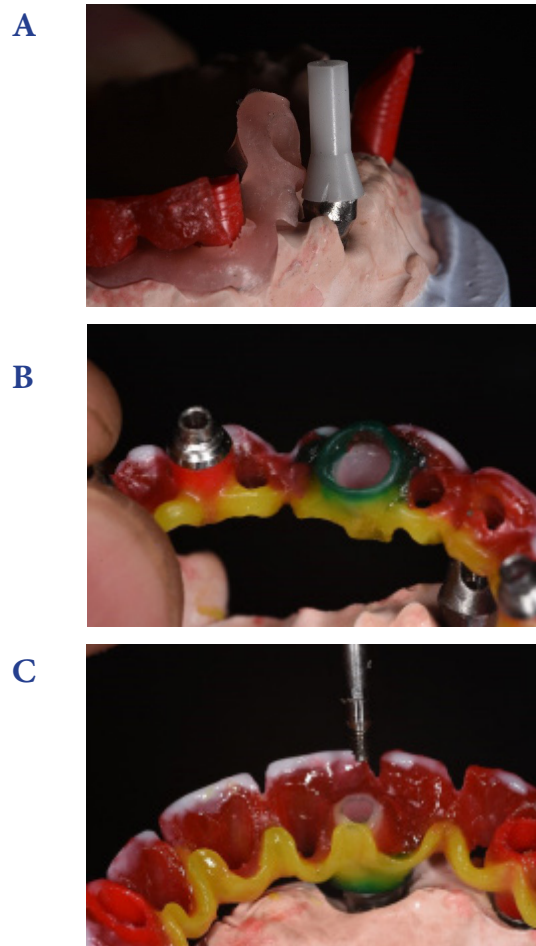
Figure 6. Modified multi-unit abutment (a) Cylindrical reconstructed part with wax (b) Lingual view of the frame (c).

Then the necessary buildups and supports for this frame were created by wax. (Figure. 6 a to c). Finally, the frame after casting with base metal alloy (Supercast Industries base metal alloysuper cast) and the necessary adjustments for the frame was sent for the frame test, and after receiving the Prosthodontist's confirmation that the frame is passivefit and it was suitable, the restoration entered the porcelain stage Using fuse-to-metal porcelains (VITA Zahnfabrik VMK Master kit). At first, after the Preparation of the frame for this step [4]. the surface of the frame was baked twice using Opaque wash and Opaque, and the final teeth were shaped on the surface with dentine buildup and enam-

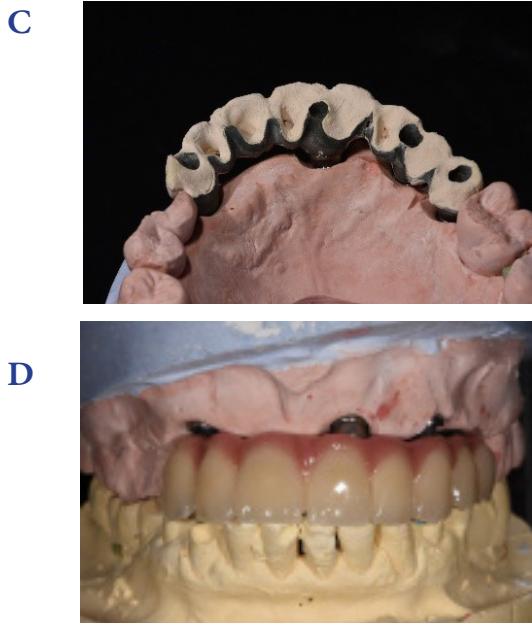
Figure 7. The final frame (A) after preparation (B) after two OPEC firing stages (pay attention to the OPEC termination point) (C) Final restoration after the glaze and polishing stage (D).

el. (Figure 7 a to d).
