## Management of Separated Instruments Using Ultrasonic Technique and a Novel Loop Device (Kamand): A Case Report

**Article Type:**  
**Case Report**

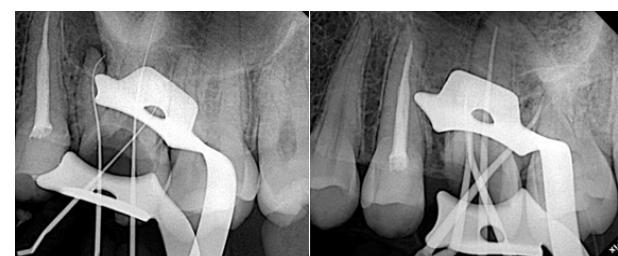
**Figure 3.** Working length determination (A), Radiographic confirmation of master Apical cone (B).

Following instrument retrieval, all canals were negotiated with a #15 K-file (Mani Inc., Japan). Working lengths were determined using an electronic apex locator (Propex IQ, Dentsply Sirona, USA). All canals were instrumented to size 25/04 using M3 rotary files (UDG, Changzhou, China) and irrigated with 2.5% sodium hypochlorite solution (Kobalt, Tehran, Iran). Patency was maintained throughout the procedure using a #10 file. Final irrigation was performed with normal saline for 2 minutes using a 30-gauge side-vented needle (UDG, Changzhou, China). Root canal obturation was completed using the warm vertical condensation technique with Meta gutta-percha points (Meta Biomed, South Korea) of size 25/04 taper and AH Plus sealer (Dentsply Sirona, North Carolina, United States). The Fast Fill and Fast Pack system (Eighteenth Medical, Changzhou, China) was used for obturation. The tooth was temporarily restored with Coltosol (Coltene, Switzerland) and the patient was referred to the restorative department for definitive restoration.

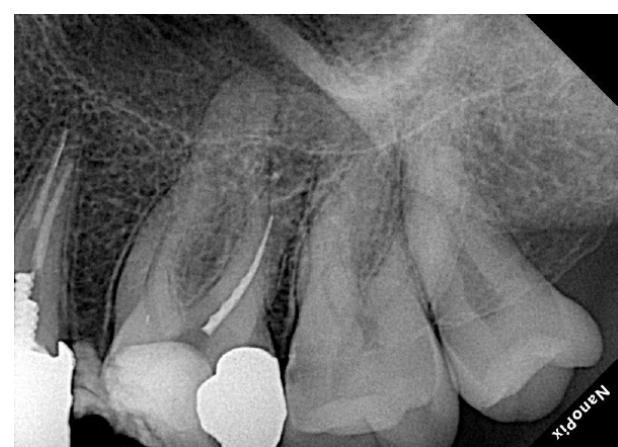
A 45-year-old male patient was referred for the management of a procedural error during endodontic therapy on the maxillary left first molar. The patient's medical history was non-contributory. The tooth was tender to percussion, and the general practitioner had initiated the initial treatment. A preoperative periapical radiograph revealed a separated instrument, approximately 10 mm in length (Figure 7), located in the first third of the distobuccal (DB) canal (Figure 5). A diagnosis of previously initiated therapy with symptomatic apical periodontitis was established.

**Figure 5.** Radiograph view showing the separated instrument.

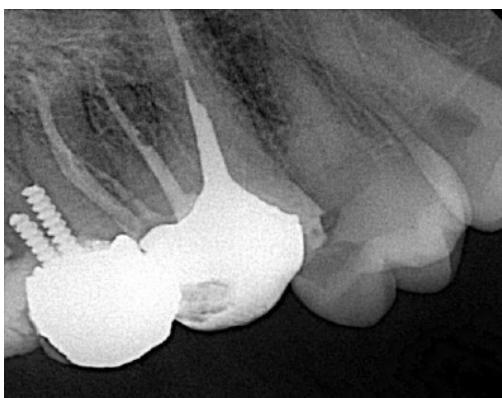
At the one-year recall, the patient was asymptomatic. Clinical examination revealed no signs of tenderness to percussion or palpation, and periodontal probing depths were within normal limits. A follow-up radiograph confirmed the placement of a definitive restoration. Although the radiographic angle did not permit a complete view of the periapical tissues, the absence of clinical signs and symptoms was indicative of a successful treatment outcome. (Figure 9).

*Figure 9.* Follow-up session showing Final indirect restoration.

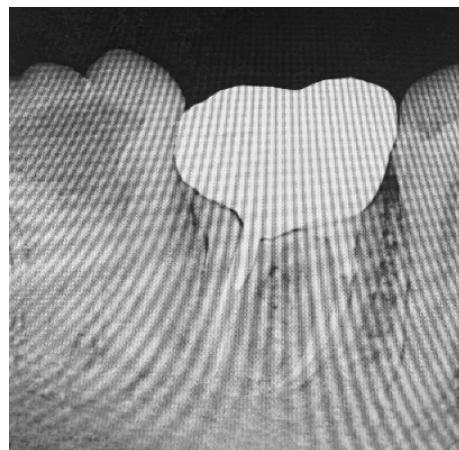
At a six-month and one-year follow-up, the patient remained completely asymptomatic. Clinical and radiographic examinations showed no adverse signs and were consistent with a favorable healing response (Figure 12). The patient was referred for a definitive cuspal coverage restoration.

*Figure 12.* 6 month follow-up.
